## 03 EXPORT CORRIDOR

### REVEGETATION OF NEAR-VERTICAL CUT BACK SLOPES

#### CASE STUDY · PARAGUAY

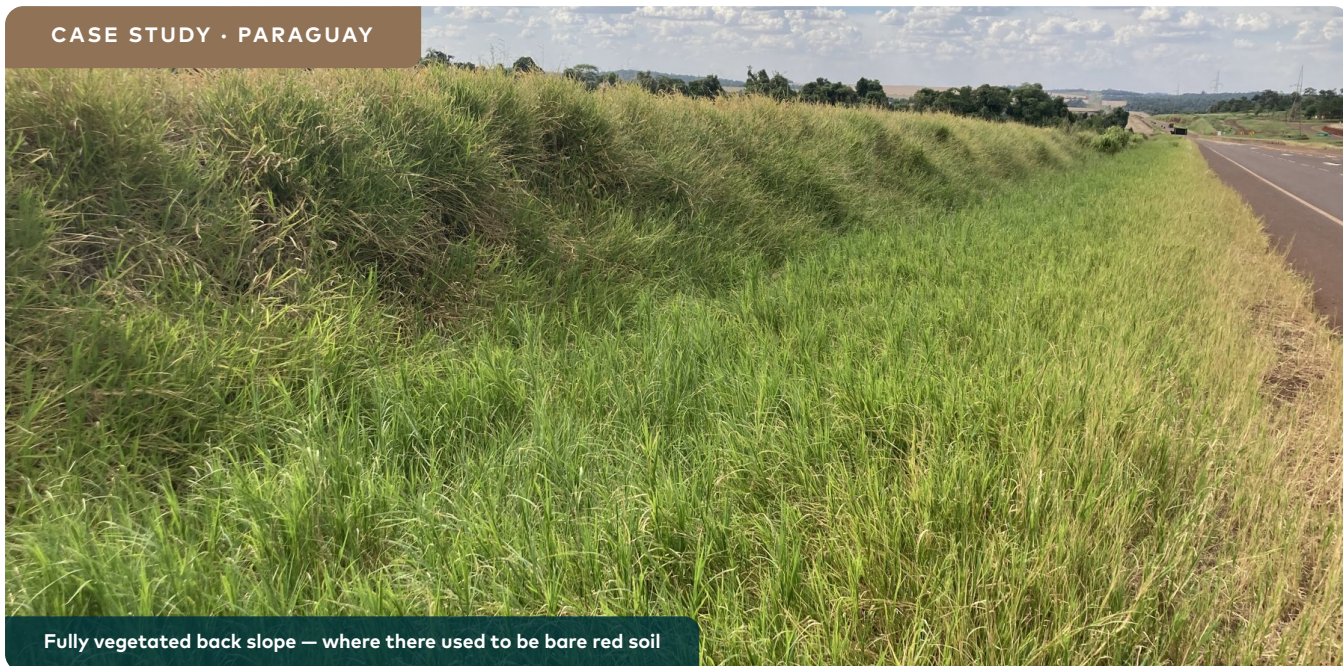
Fully vegetated back slope — where there used to be bare red soil

**The solution:** a programme of **hydroseeding with hydraulic mulches** tuned through field trials: formulation, rate and timing were calibrated over successive campaigns until the recipe that holds on the cut was found. Today the slopes are fully vegetated.

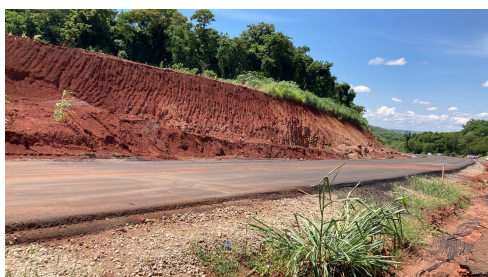
The starting point: an unprotected red-soil cut

**The challenge:** the cut back slopes of the Export Corridor were left almost vertical on the red soil of the east — a surface where water does not stop, conventional seed does not hold, and every rainfall opened new rills.

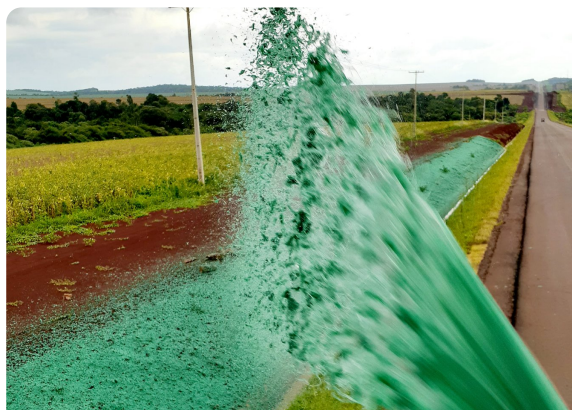
Hydraulic mulch applied with the cannon — the green colour marks the coverage
