# 01 HÉROES DEL CHACO BRIDGE APPROACHES

## SLOPE REVEGETATION AND EROSION CONTROL — ASUNCIÓN

### CASE STUDY • PARAGUAY

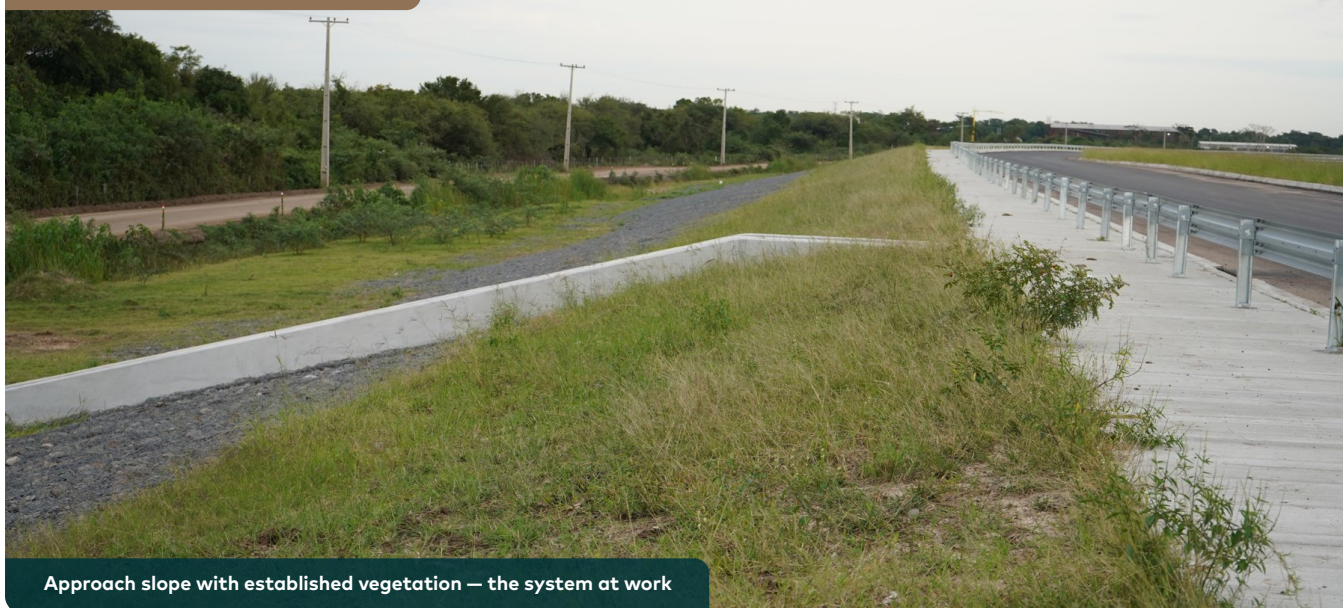
Approach slope with established vegetation — the system at work

**The solution:** slope lining with **hydraulic mulch** applied over the shaped soil and **vegetation reinforced with mats** turf reinforcement: immediate protection against erosion, and a permanent green surface that blends into the road works.

**The versatile system:** where the slope demands more, the reinforcement mat anchors the roots; where the landscape rules, the vegetation takes the lead. A single work front, with Ece crews.

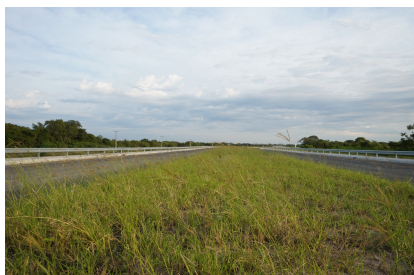
Dense turf on the embankment — the finished result

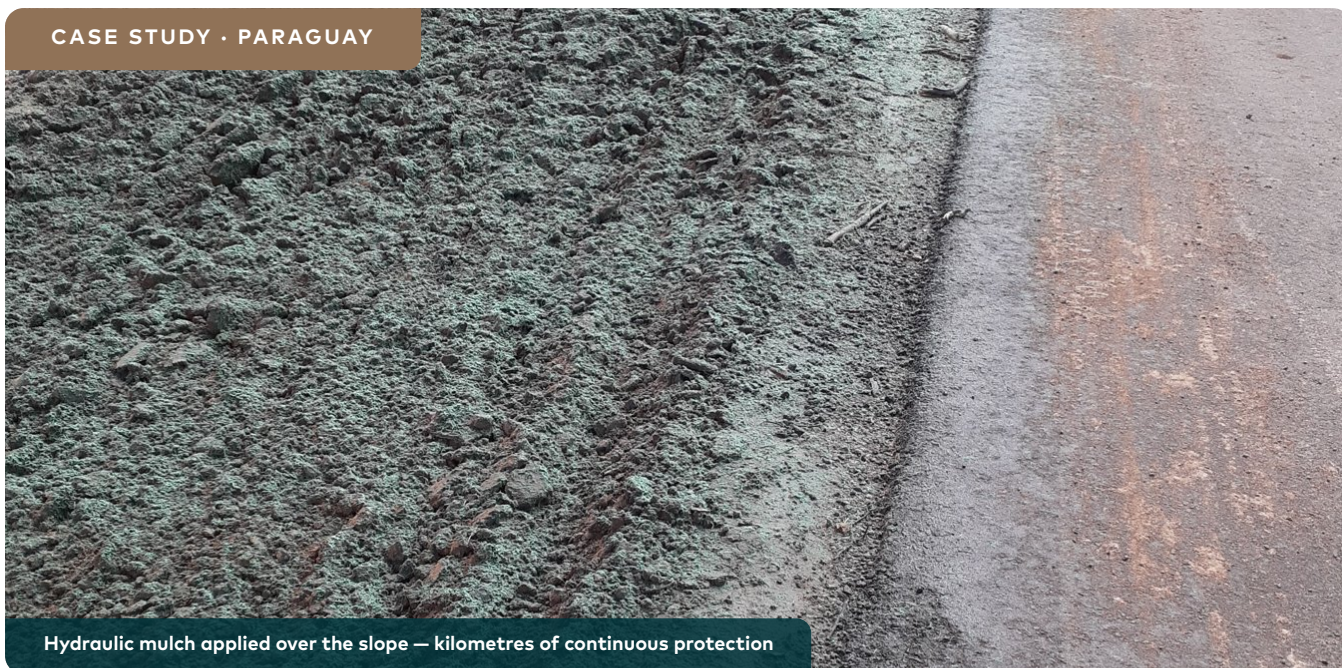
Hydraulic mulch applied over the slope — kilometres of continuous protection

**The solution:** slope protection by means of **hydraulic mulches** applied by Ece, with the formulation tuned to each soil. Over **one million square metres** carried out on 11 of the 21 sections of the works — the largest hydroseeded area applied in Paraguay.

**Why it works:** the mulch pins the seed and the moisture down against the Chaco wind and sun, and protects the soil from day one, without waiting for the vegetation to come up.

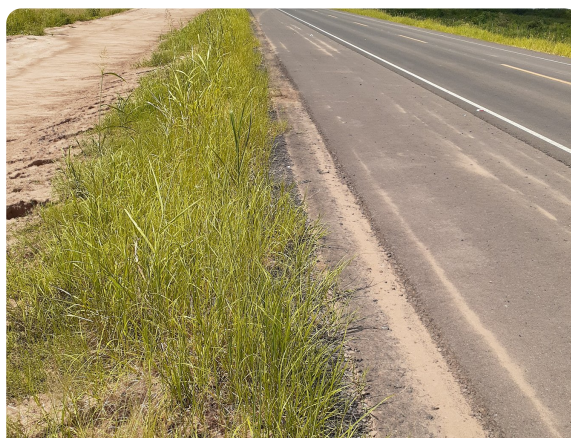
Vegetated slope beside the carriageway — the result

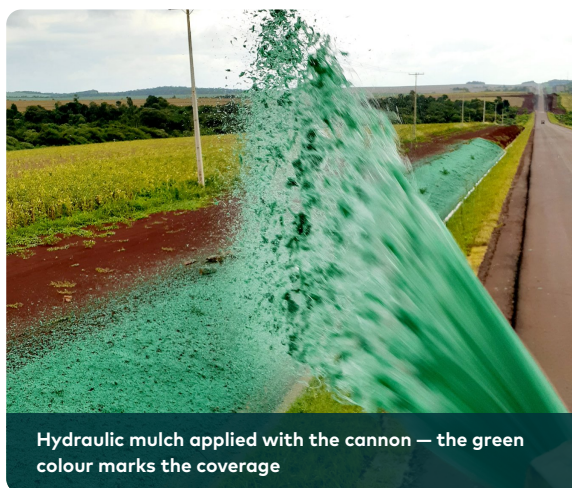
Hydraulic mulch applied with the cannon — the green colour marks the coverage

**The solution:** a programme of **hydroseeding with hydraulic mulches** tuned through field trials: formulation, rate and timing were calibrated over successive campaigns until the recipe that holds on the cut was found. Today the slopes are fully vegetated.

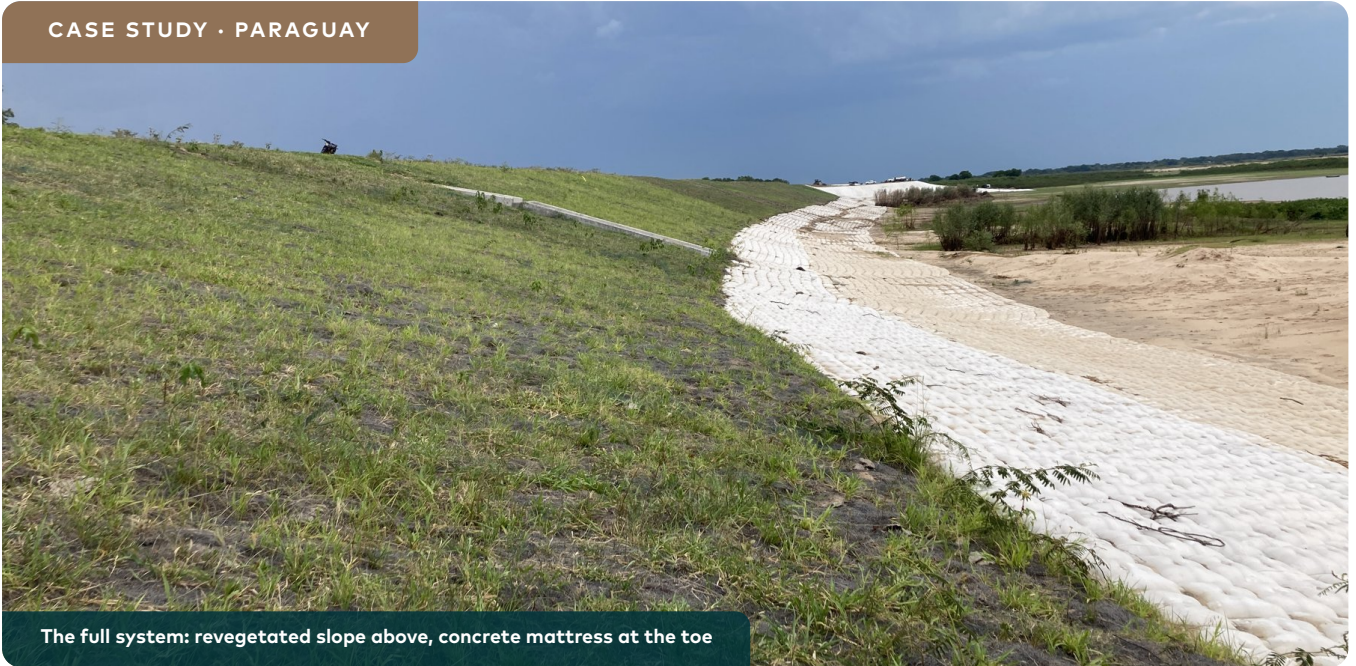
The full system: revegetated slope above, concrete mattress at the toe

**The solution:** **hydraulic mulches** to establish vegetation on embankments and banks, and **turf reinforcement mats** in the channels, where the reinforced grass takes the flow of the floods. Vegetation as engineered lining.

**One party responsible:** in Pilar, Ece delivered the complete system — concrete mattresses manufactured in the city itself, hydroseeding and turf reinforcement — with the same technical team.

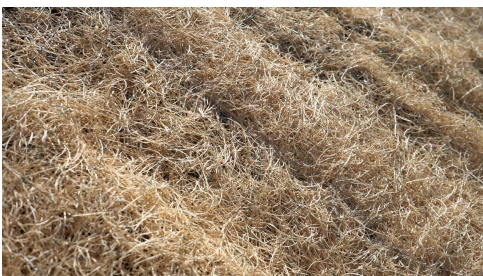
Germination over the mulch — the diversion channel takes
